## **Application of Effectiveness Monitoring to Habitat Restoration Projects in the Columbia River Estuary**

**May 16, 2012**

**Columbia River Estuary Study Taskforce**

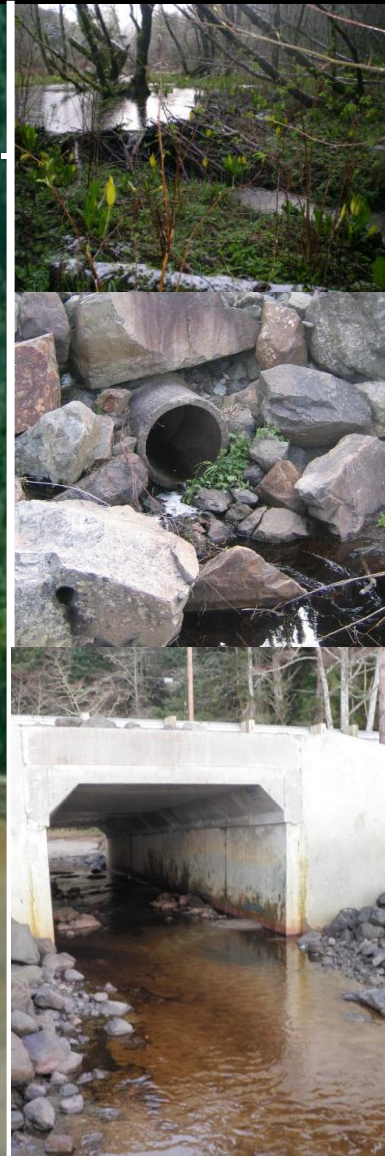
# Fort Columbia Tidal Reconnection

- Wetland cutoff by Hwy 101
- Fish passage culvert, wetland, LWD, revegetation
- Completed Spring 2011
- Pilot channel excavated
- Passive restoration

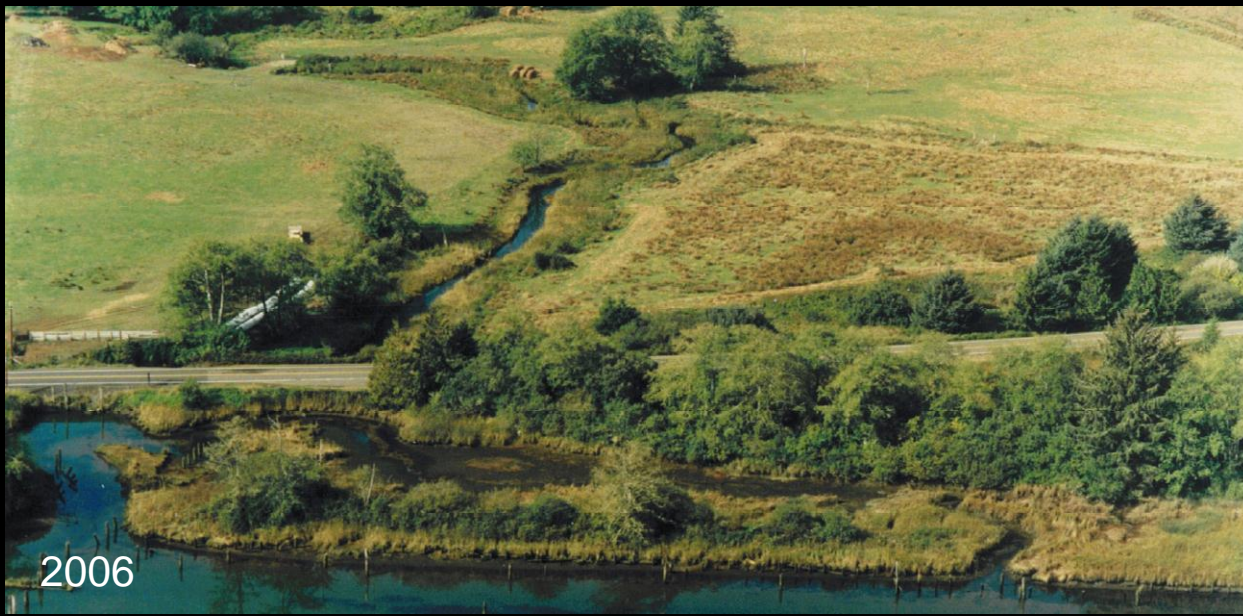
2006

✓ 45 acre Wetland cut off by tidegate installation through Ft Clatsop Road.

✓ Tidegate removed. bridge installed in 2007.

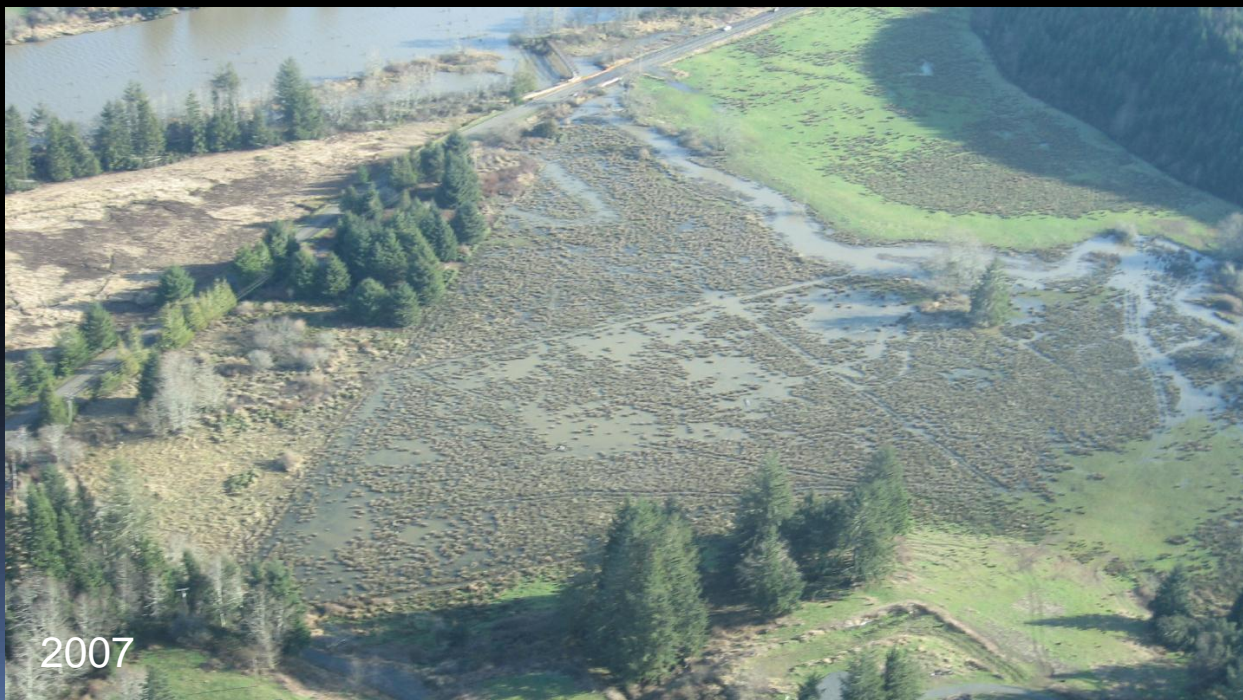
2007

✓ Vegetation response in northern portion.

✓ Degraded wetland vegetation persists and no channel formation on southern area.

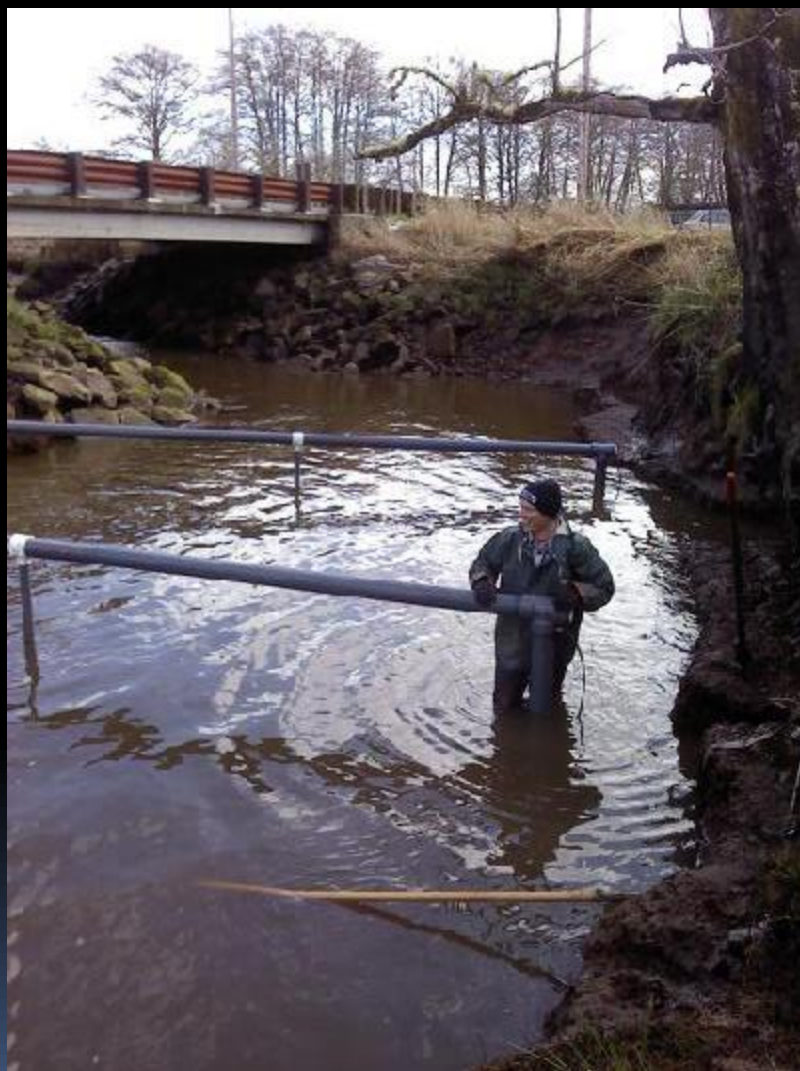
# Pit Tag Array –Colewort Creek Restoration Site

Capture method: Dipnet

Length: 66mm

t\_species: 1 (Chinook)

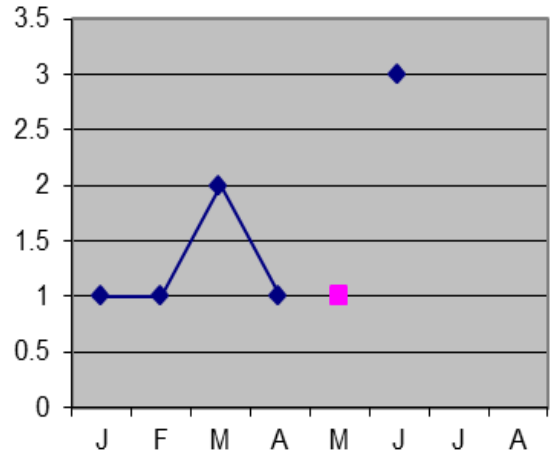
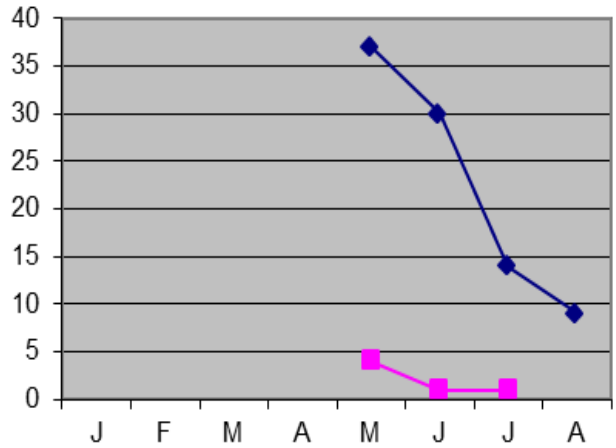
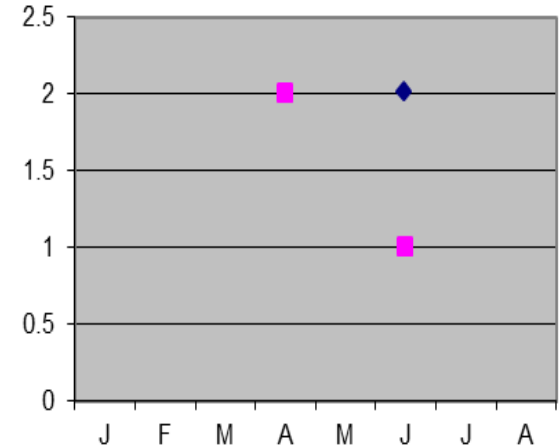
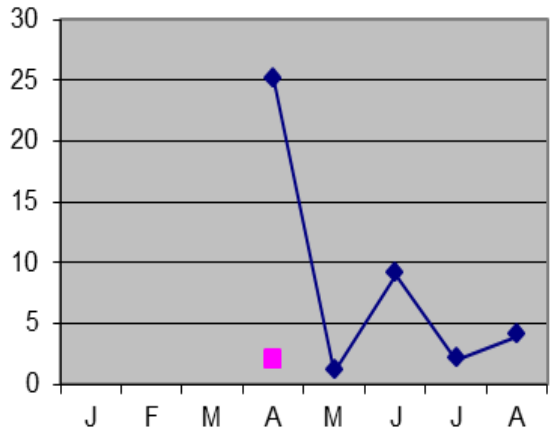
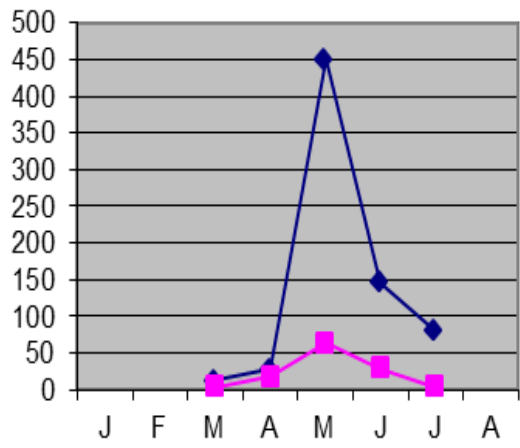
# Temporal Distribution of Coho at South Slough and Alder Creek 2007 - 2011

◆ South Slough  
 ■ Alder Creek
