Effects of Estuarine Wetland Restoration on Flood Management: The Lower Grays River Experience

Ian Sinks
Columbia Land Trust

Kandoll Farm Restoration Project

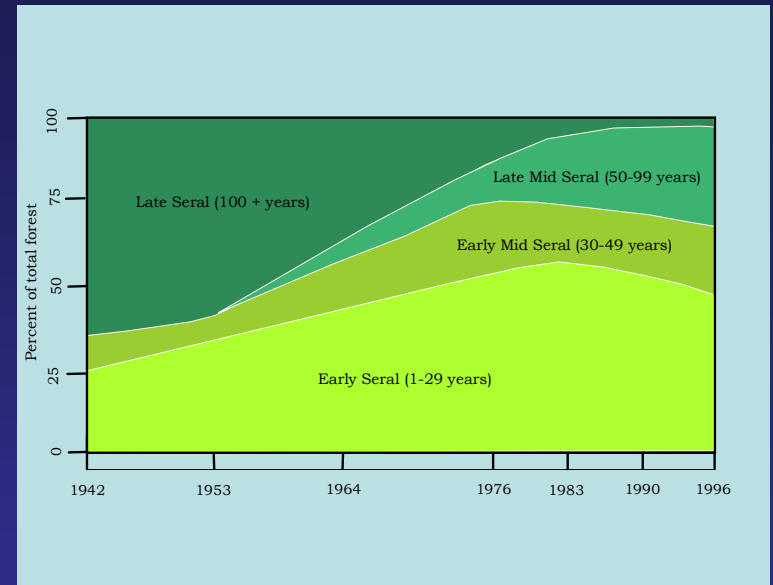
Percent of Gray's River forest in early – late seral stages 1942-1996 (Mark Scott 2001).

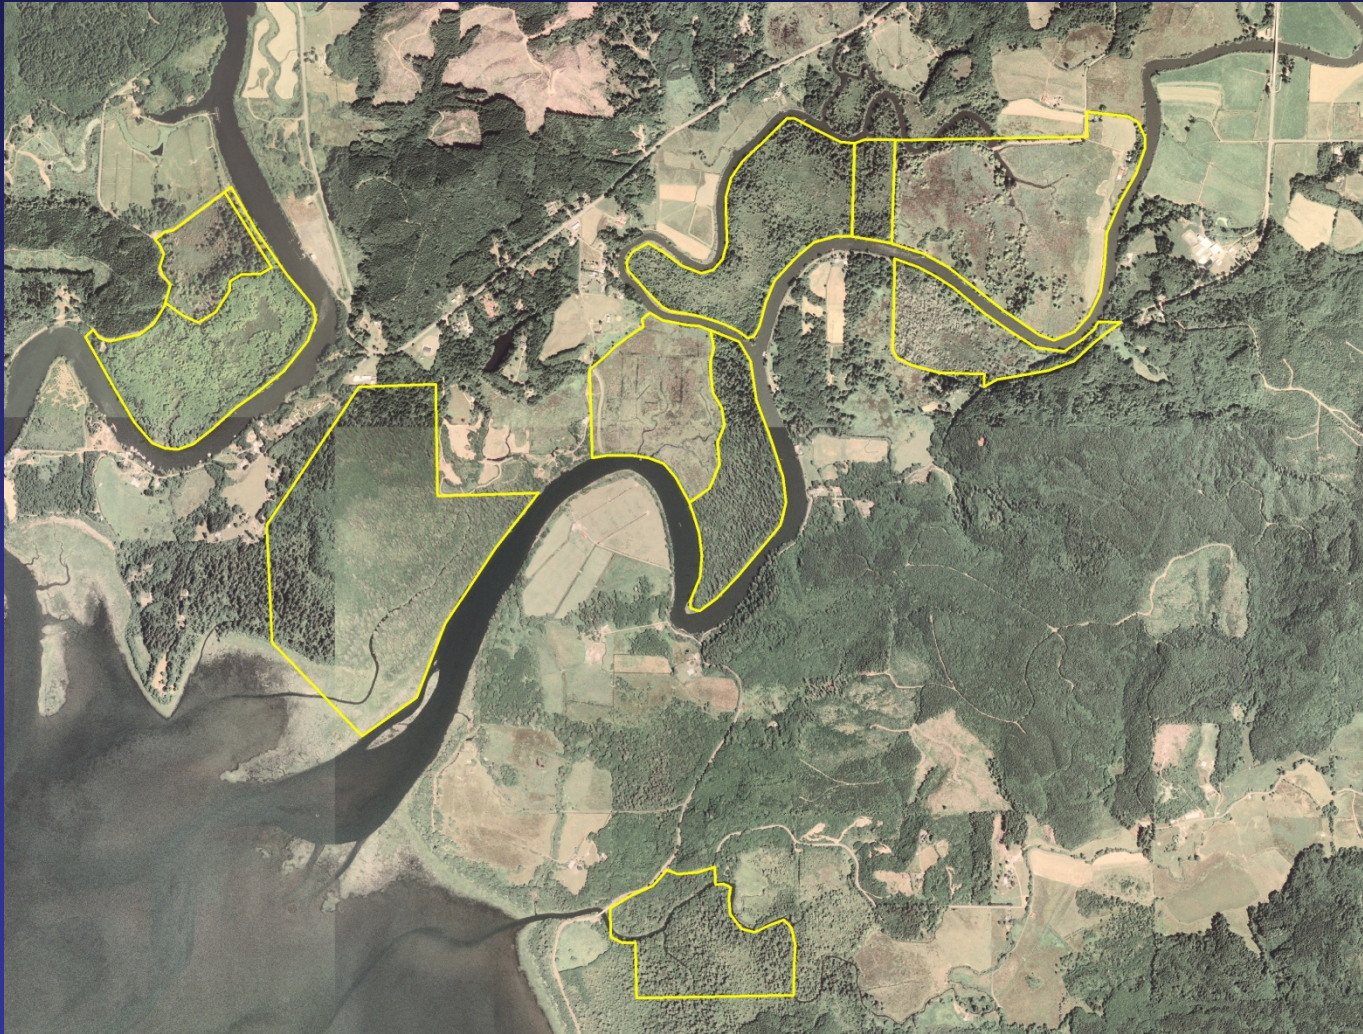
Columbia Land Trust Conservation Properties, Grays Bay Watershed

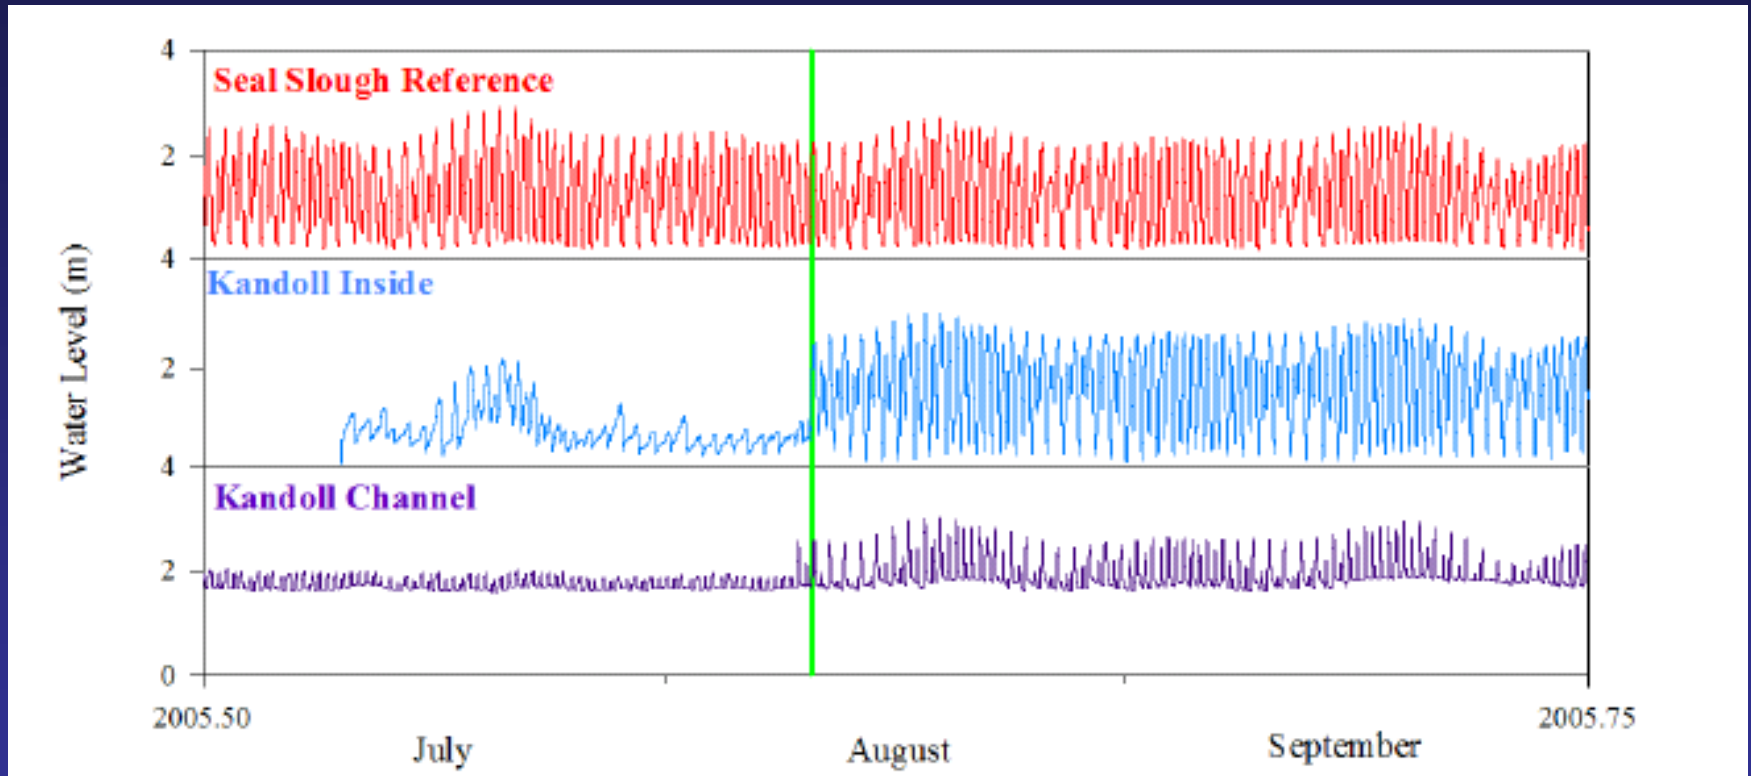
Habitat Forming Process: Hydrology

Source: PNNL Cumulative Effects Annual Report 2006

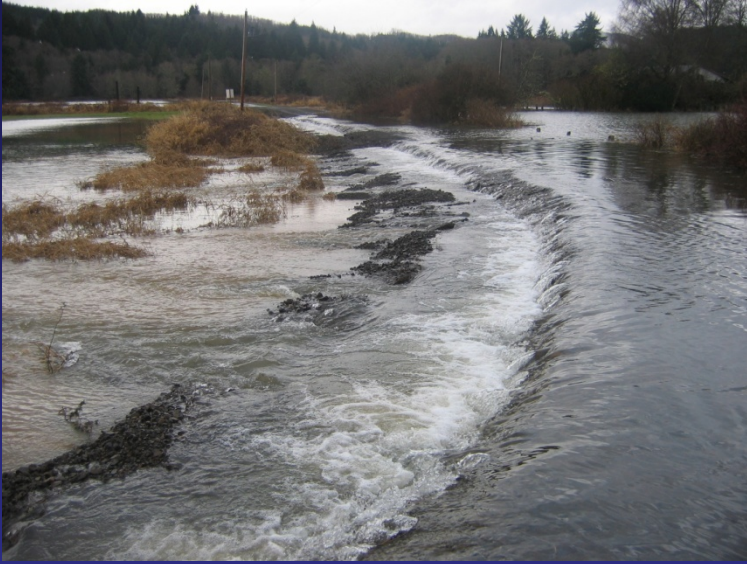
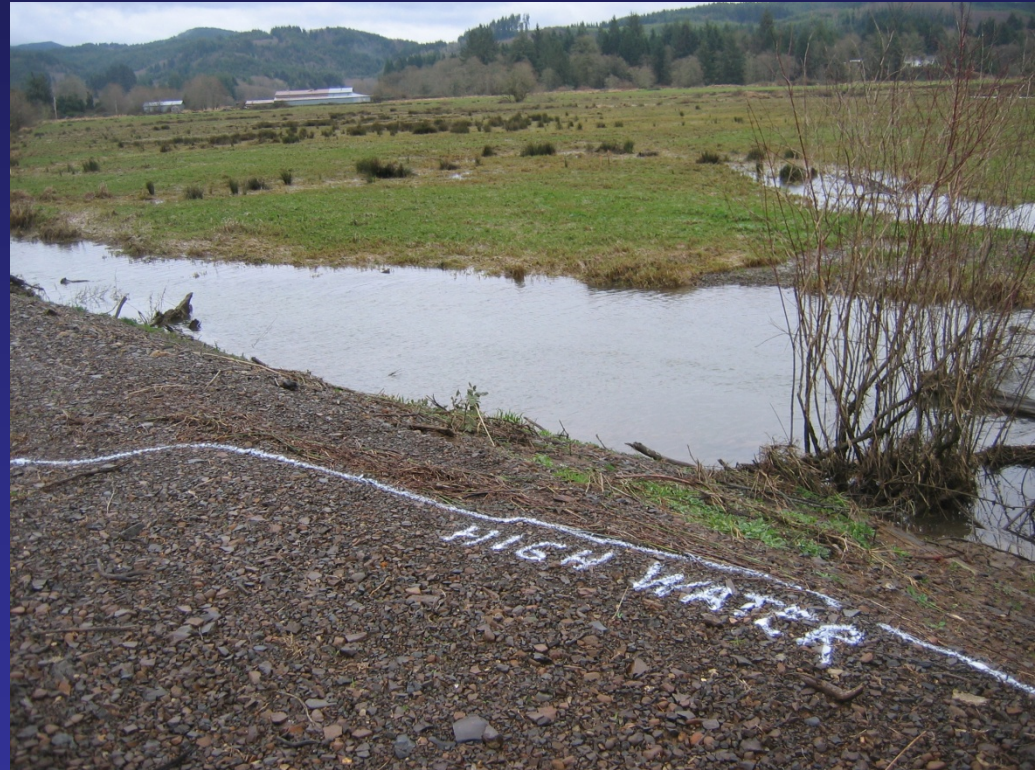
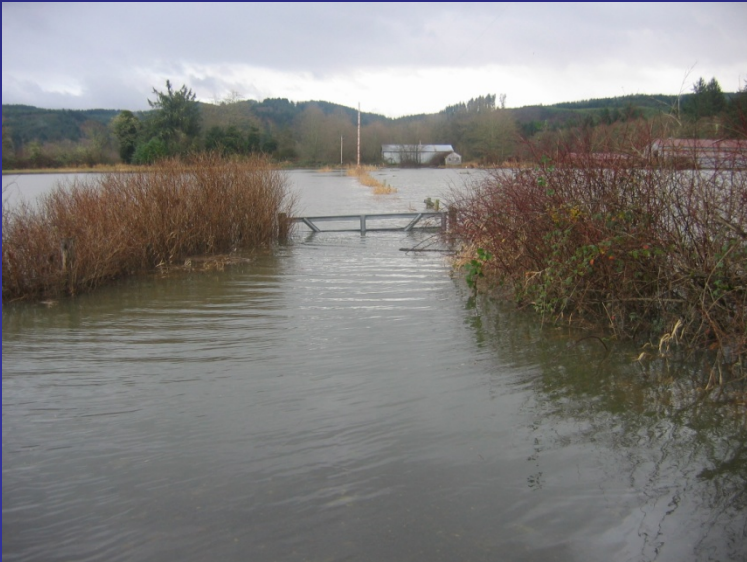
January and February 2006 Flood Events

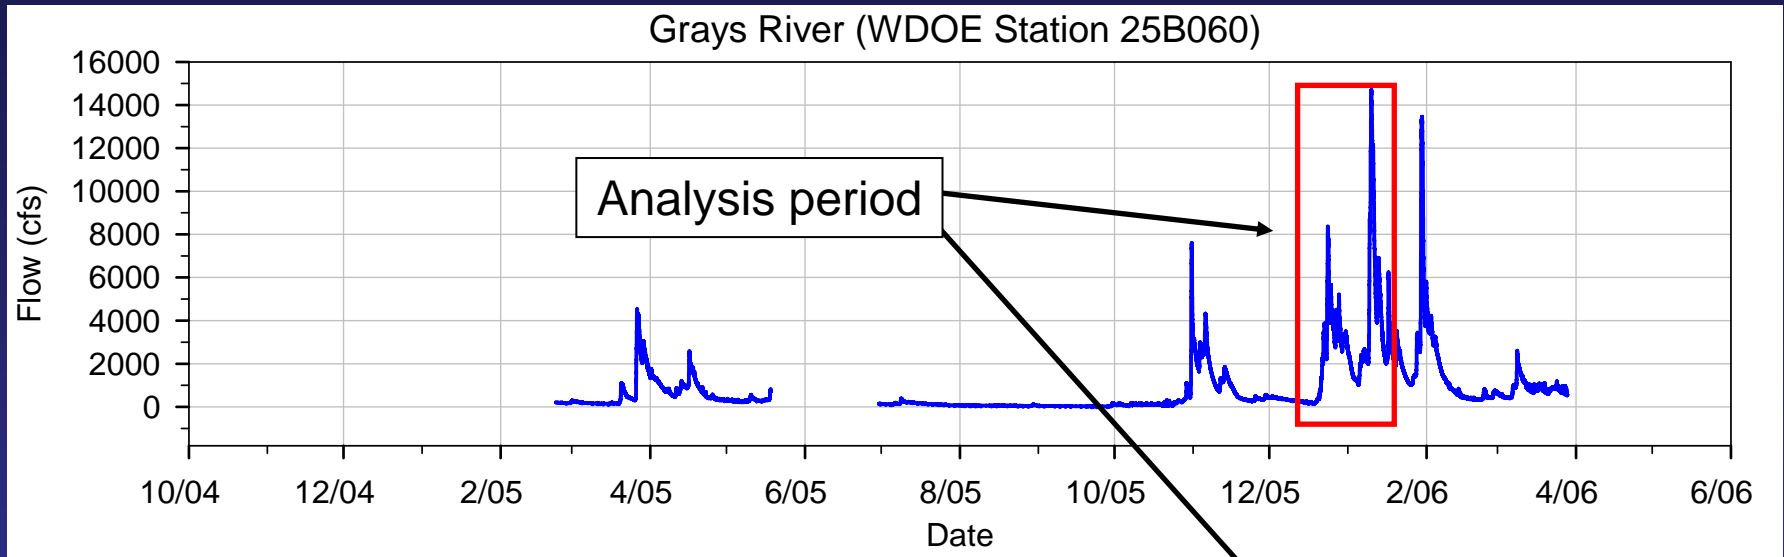
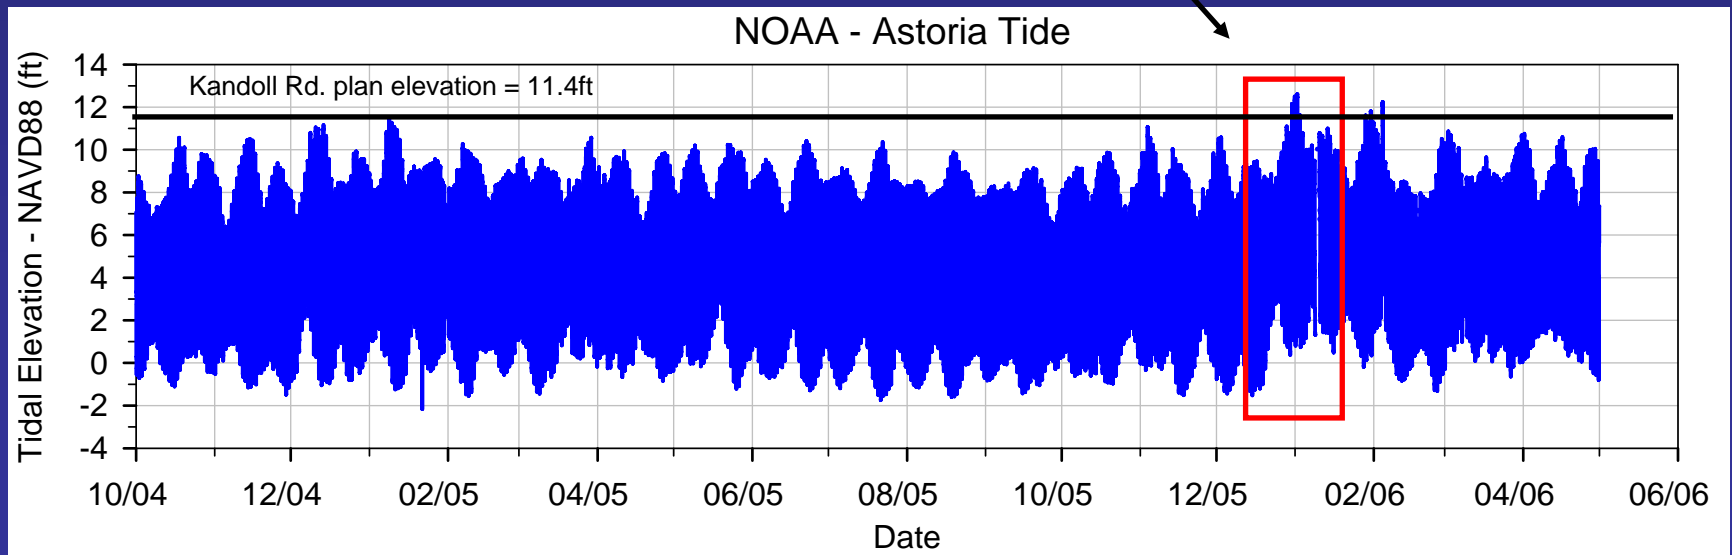
Hydrologic and Tidal Conditions

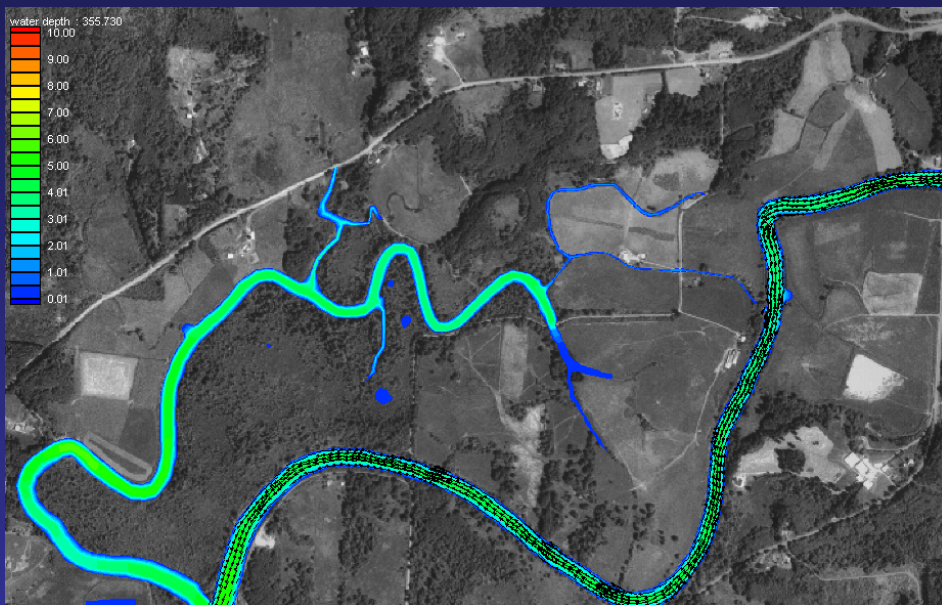
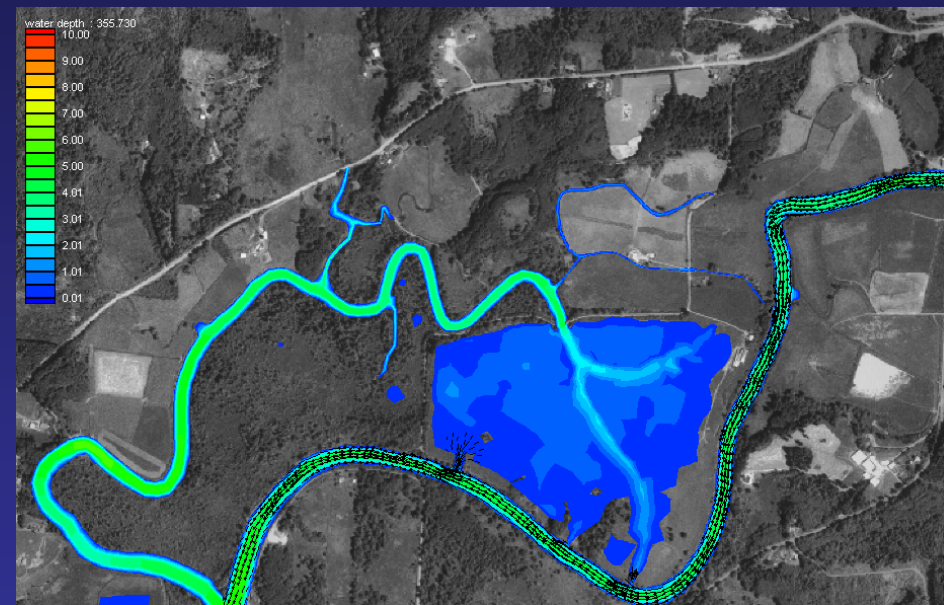
Normal Flow and Tide (High)

▶ Pre Construction

▶ Post Construction

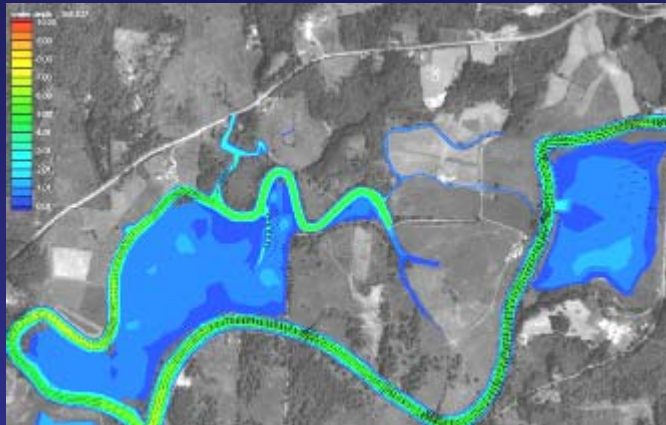
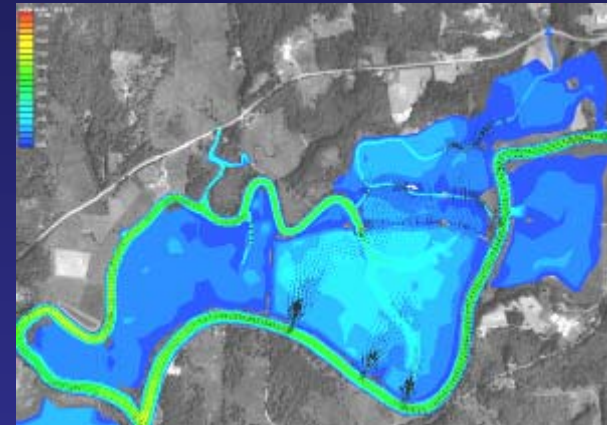
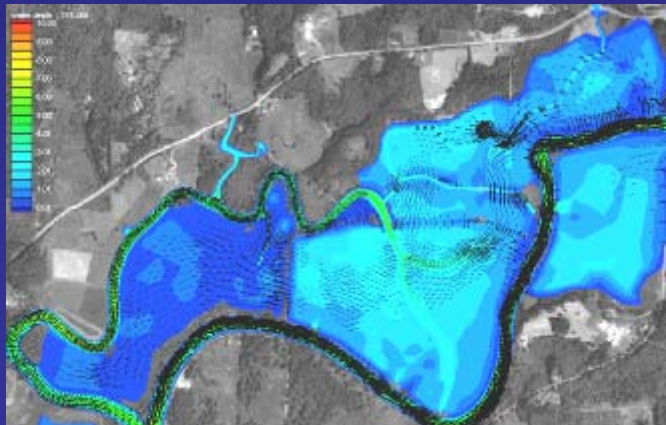
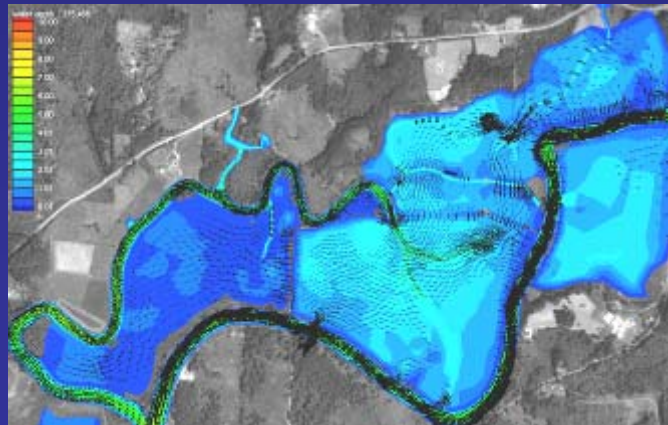
Hydrodynamic Modeling: Local Off-Site Assessment, Wetted Area Indicator

Pre Construction

Post Construction

Tide

Flood

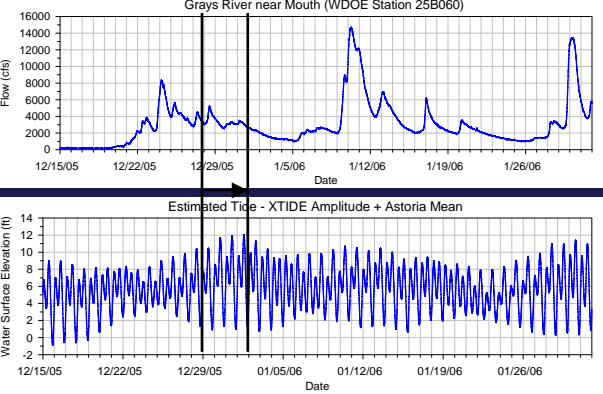
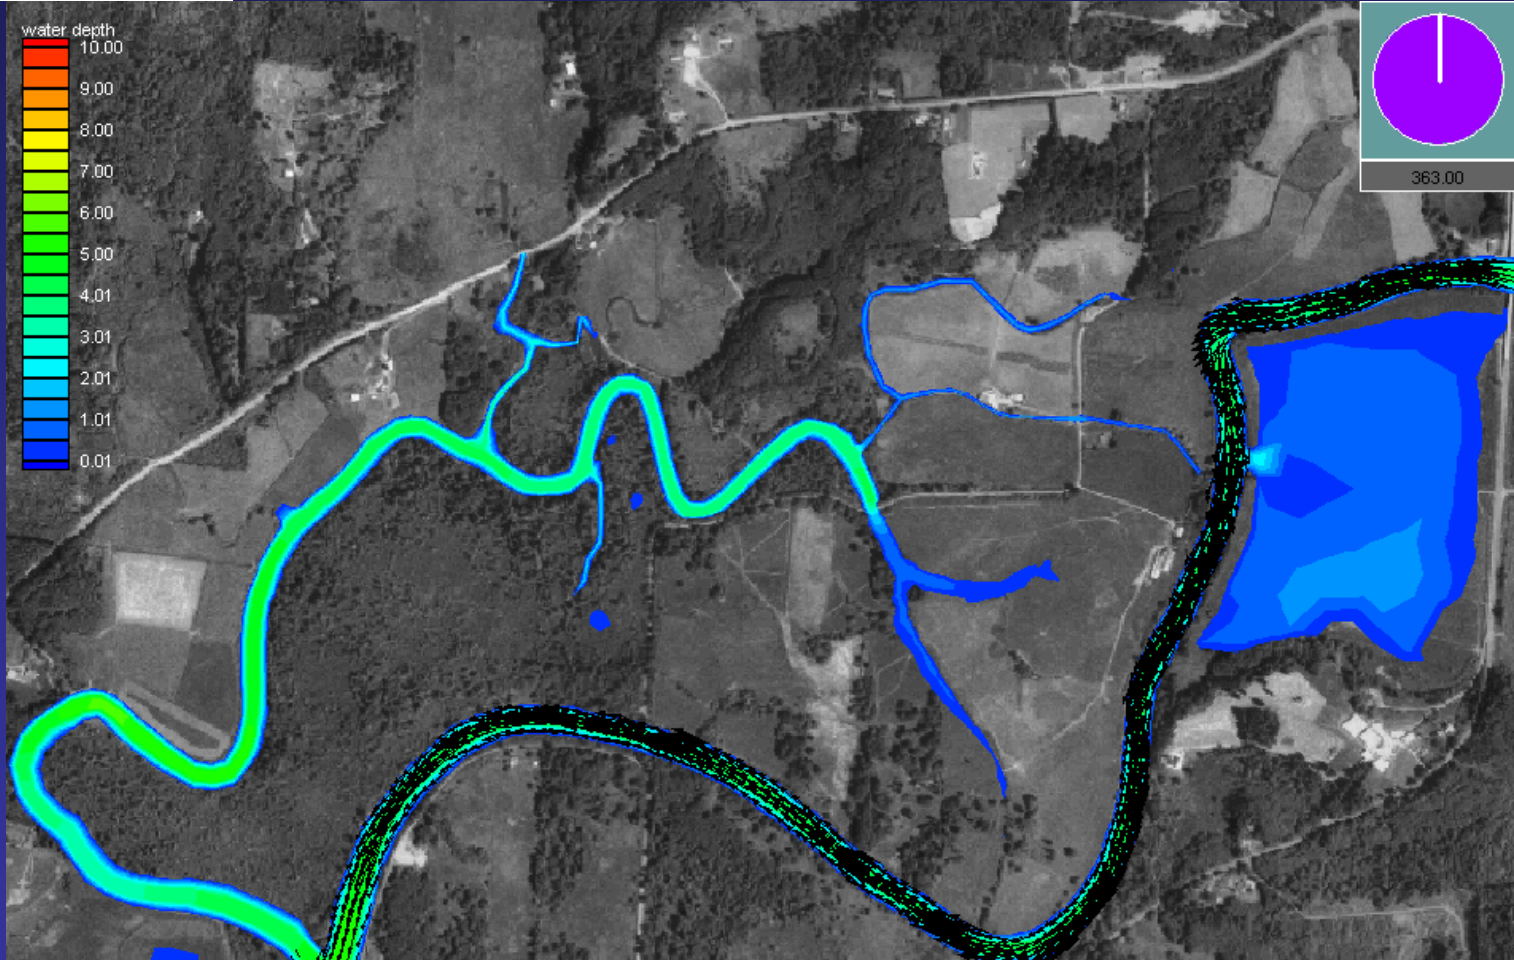
Pre-Construction 12/31/2005 - Tide

12/29/05- 1/2/06

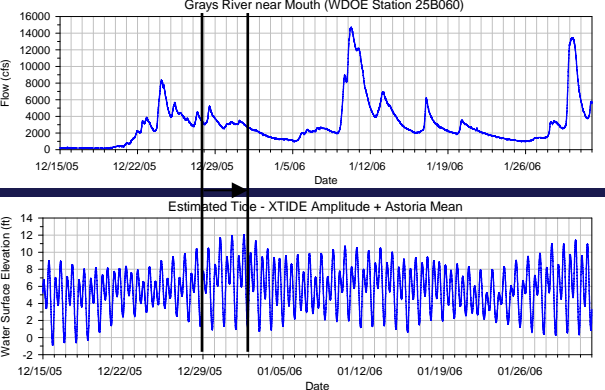
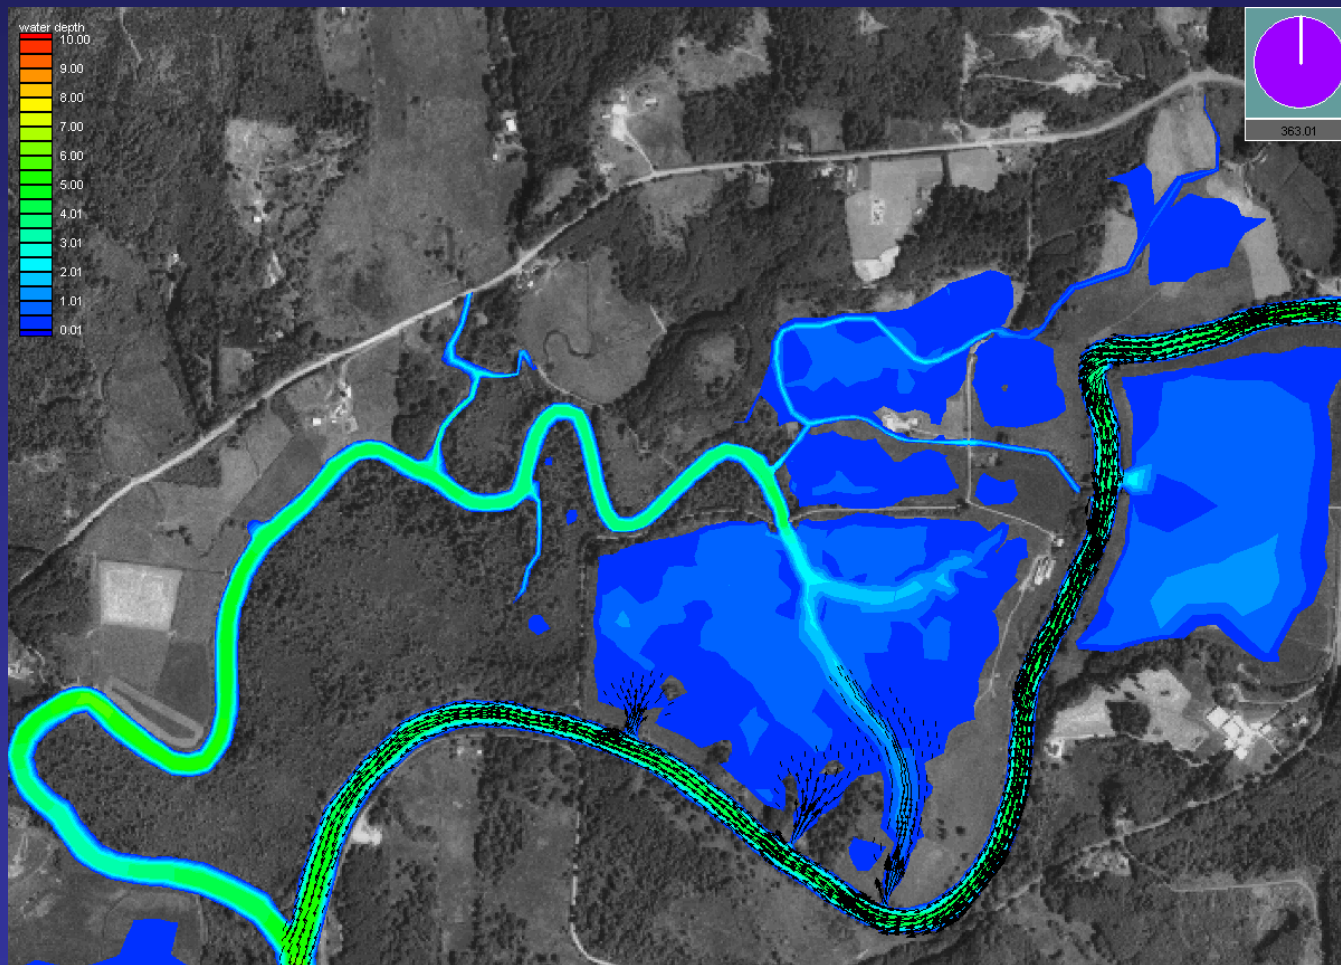
Post-Construction 12/31/2005 - Tide

12/29/05- 1/2/06

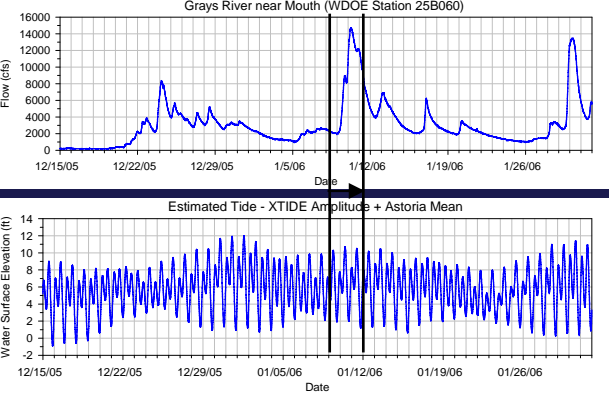
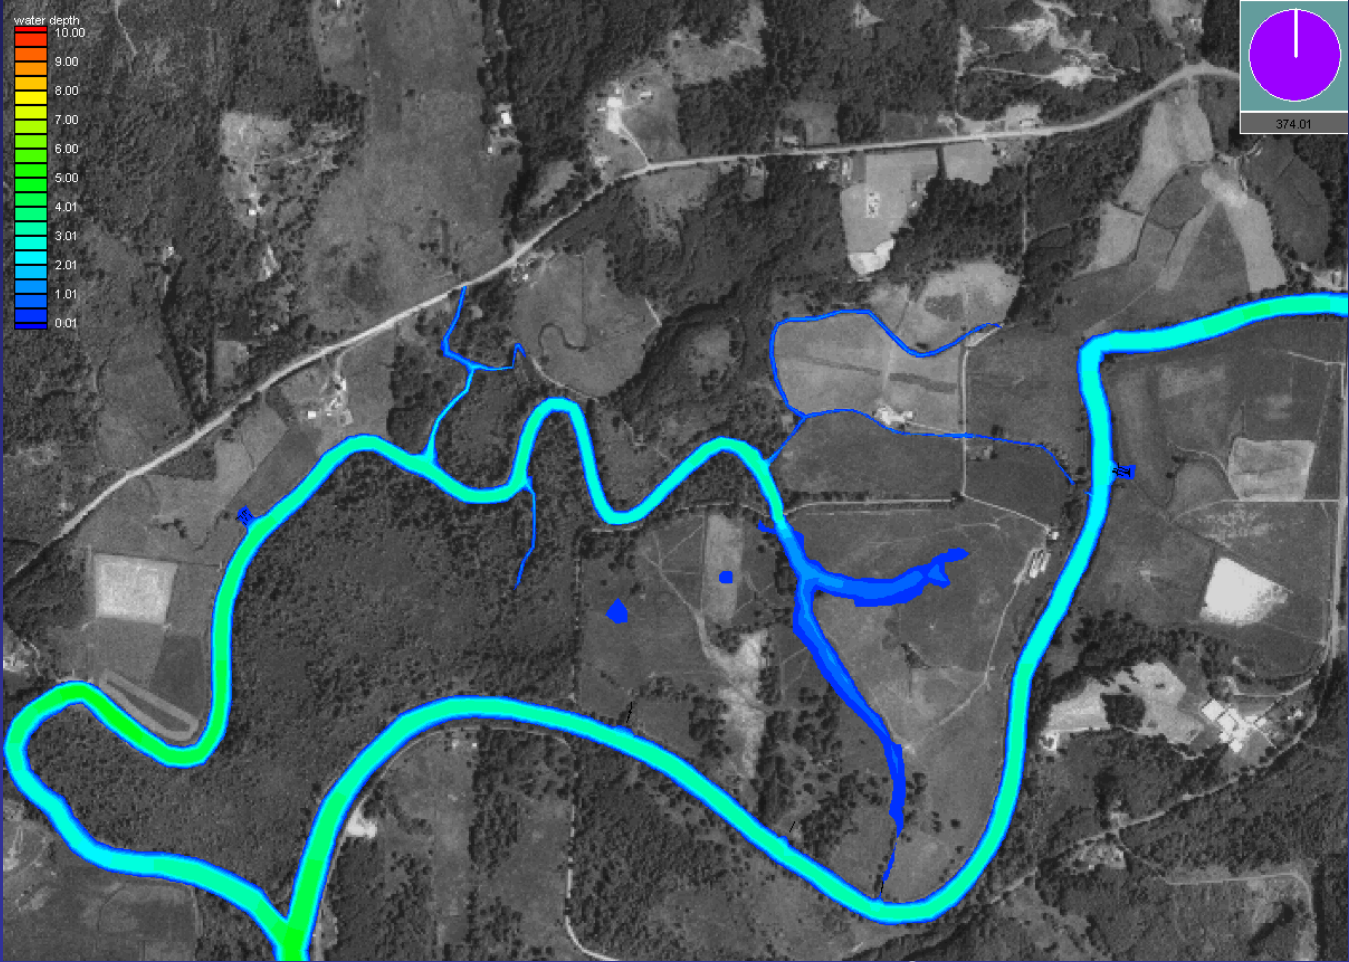
Pre- and Post-Construction 1/10/2006 - Flood

1/8- 1/12/2006

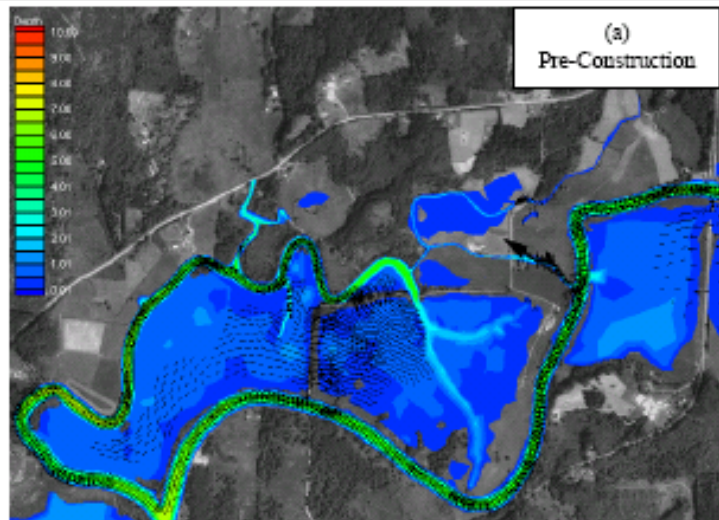
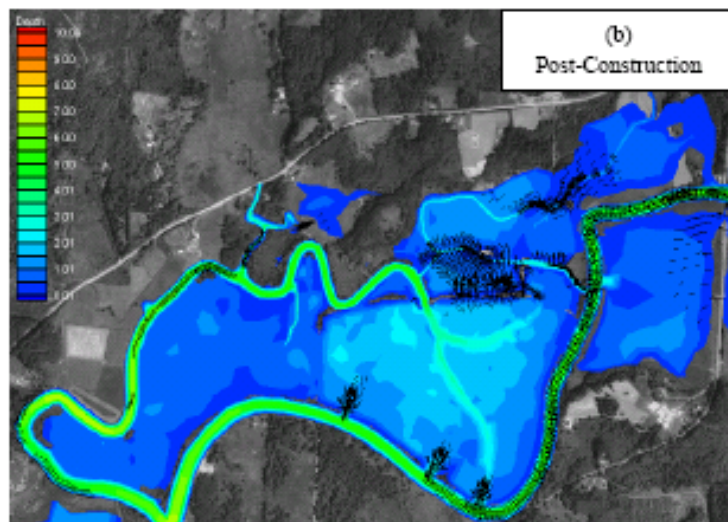
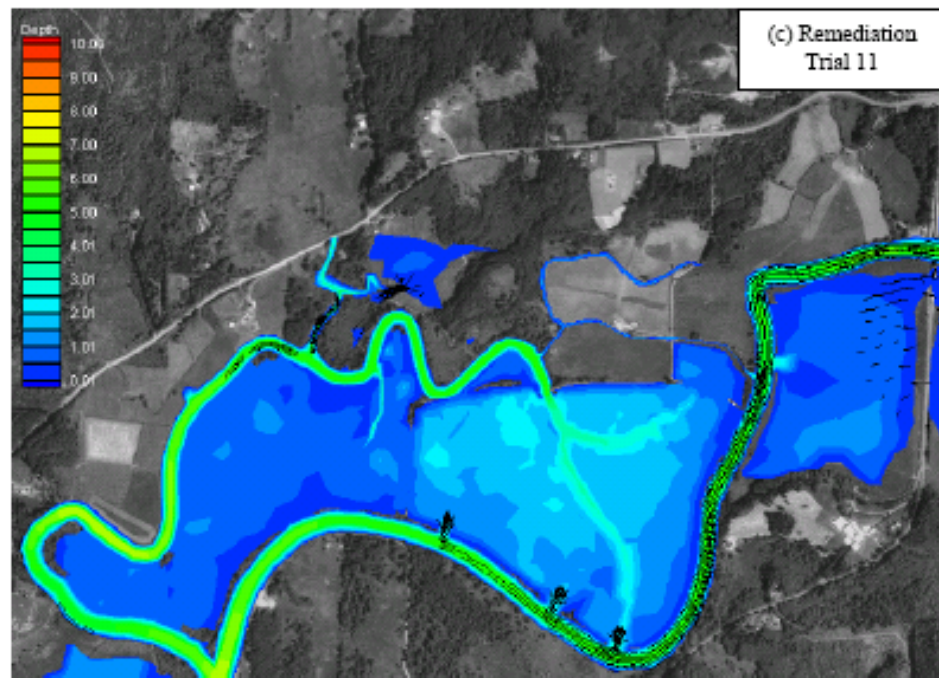
Note: The model results are from 1/1/06 14:04.

FIGURE 5.2
Comparisons of Inundated Areas for the Remediation
Condition to Pre- and Post-Construction Conditions

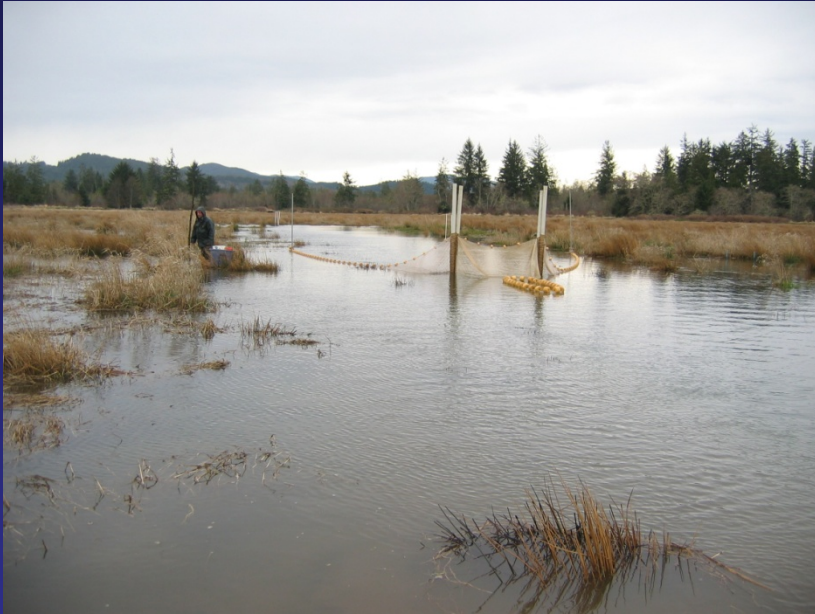
Trap Netting

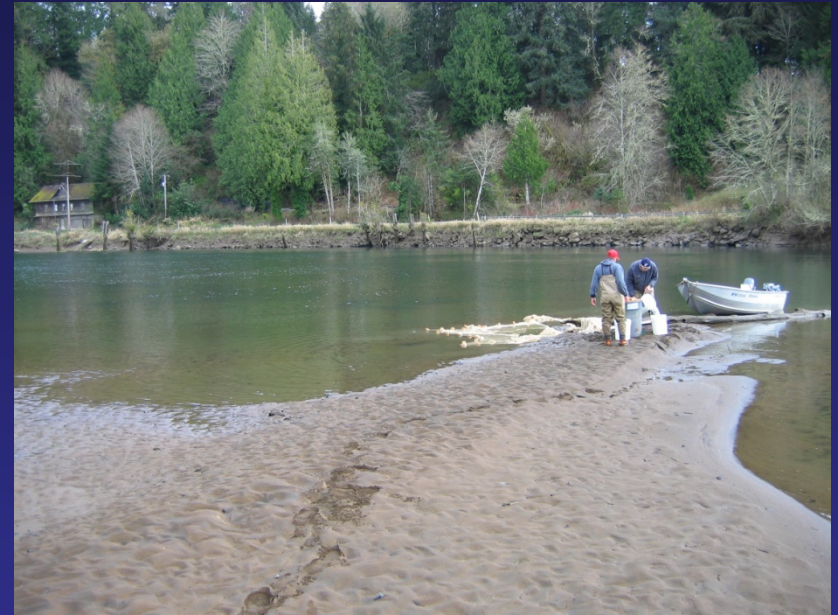
Seine Netting

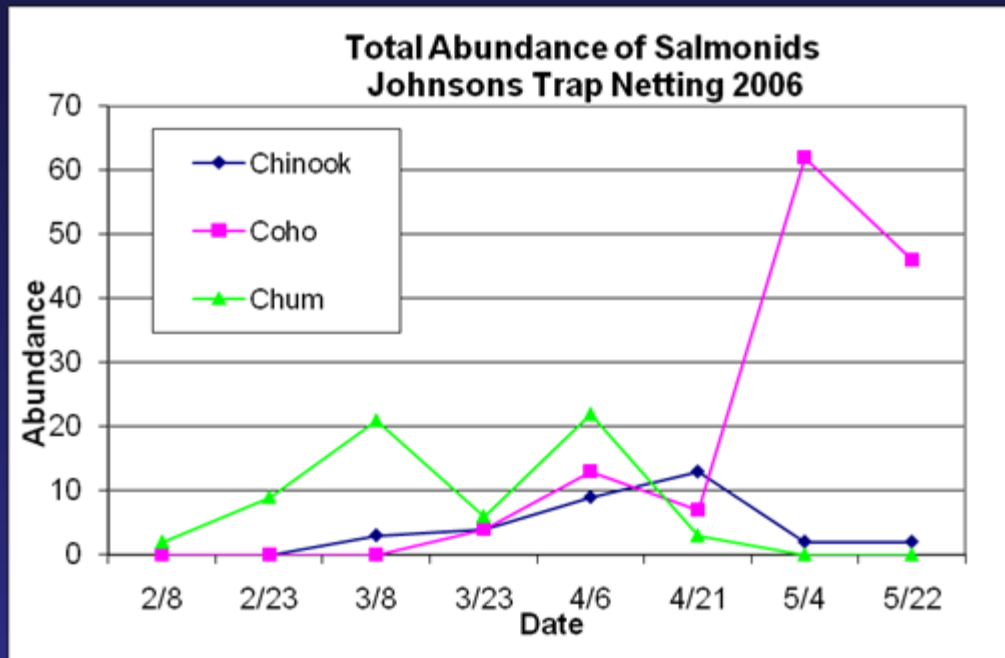
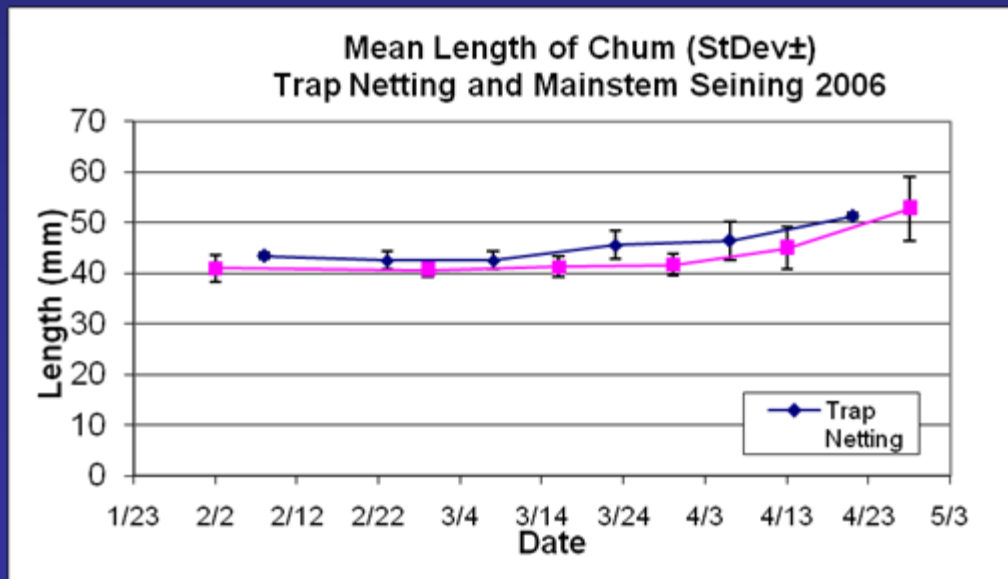
Salmonid Use
